Contact Voltages due to Inadvertently Energized Conductive Objects and Surfaces

**A Summary of Materials
Presented at Annual Jodie Lane
National Conference**

November 2009

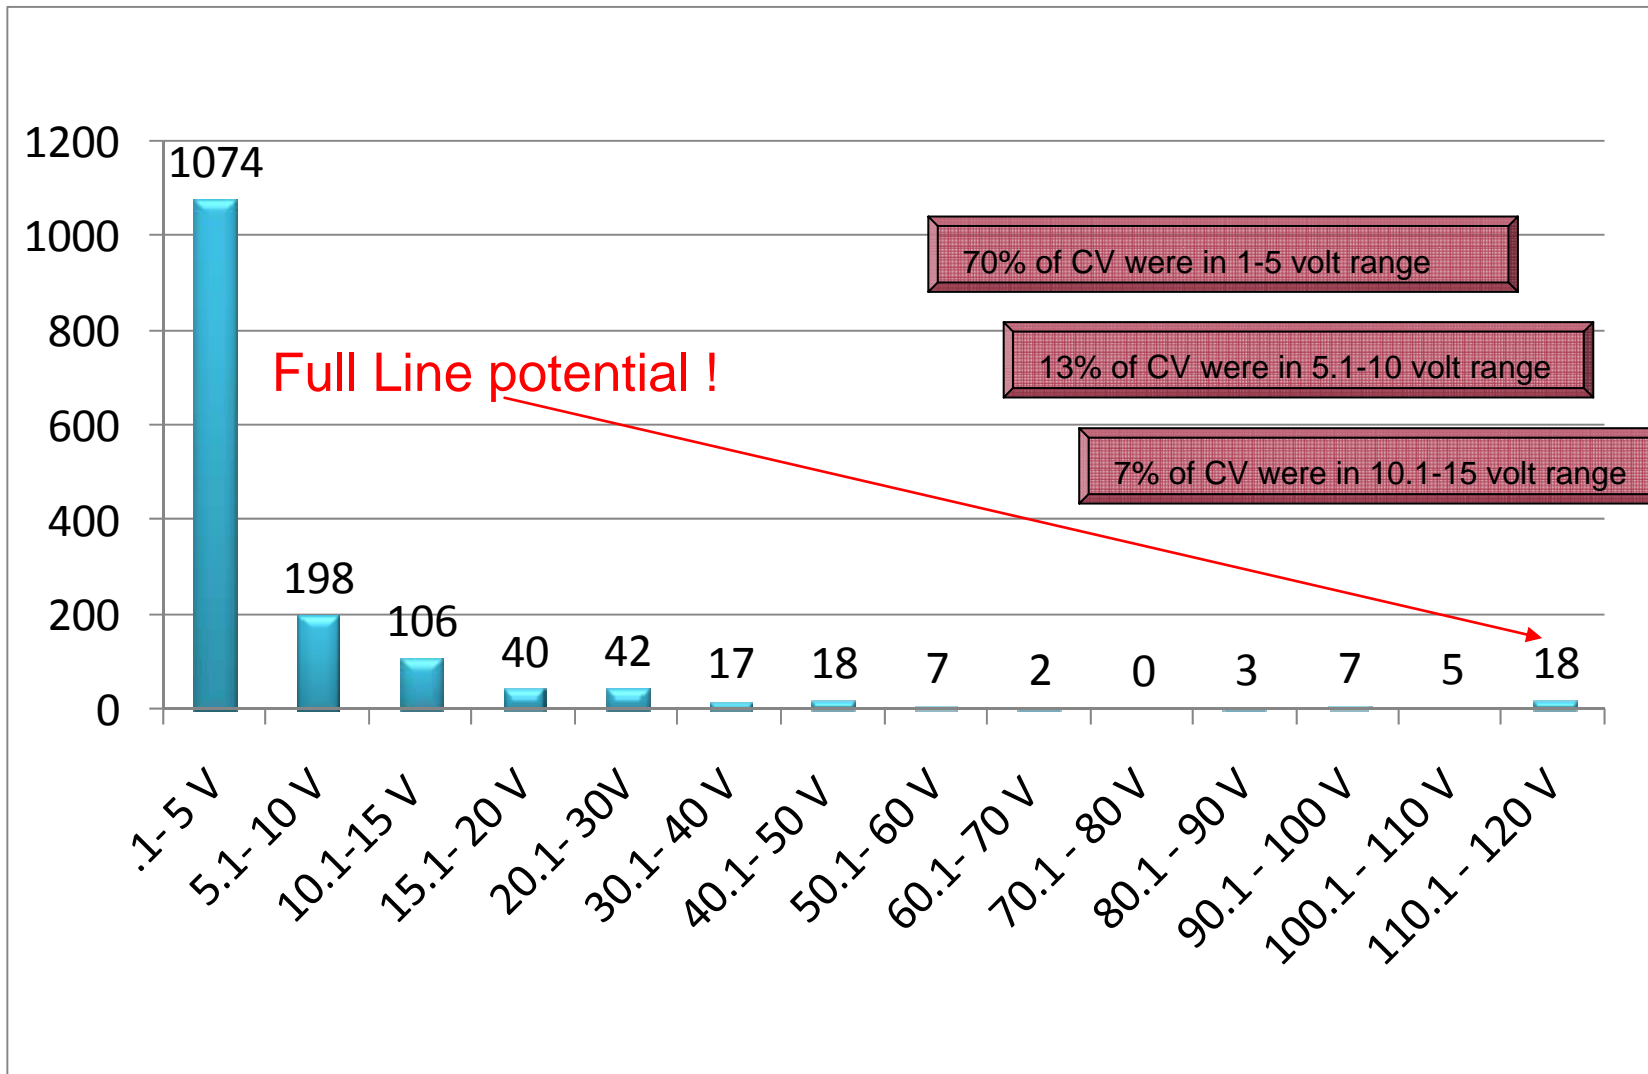
Contact Voltage Histogram

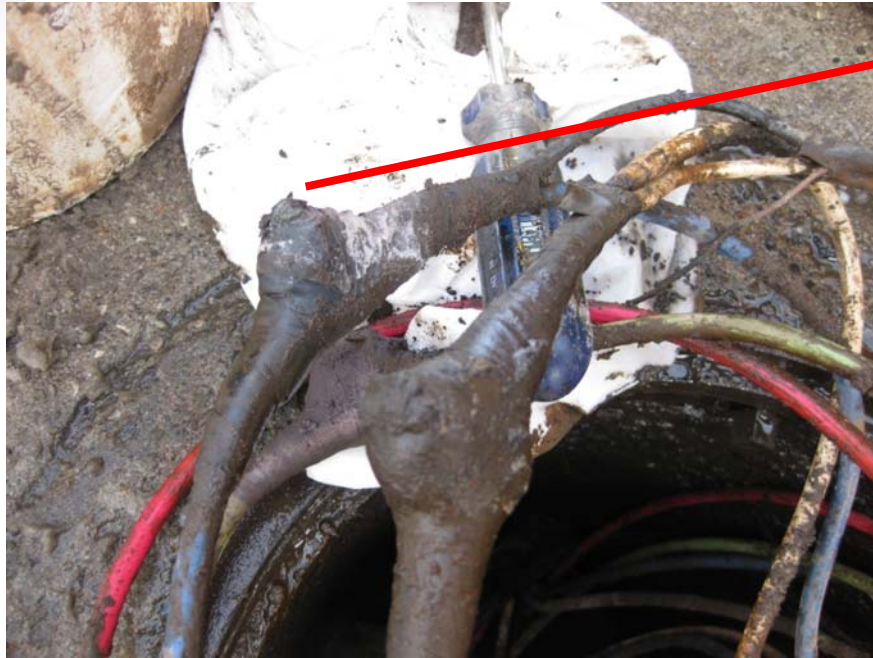
120 volts
measured

- Split-bolt tape insulation has degraded

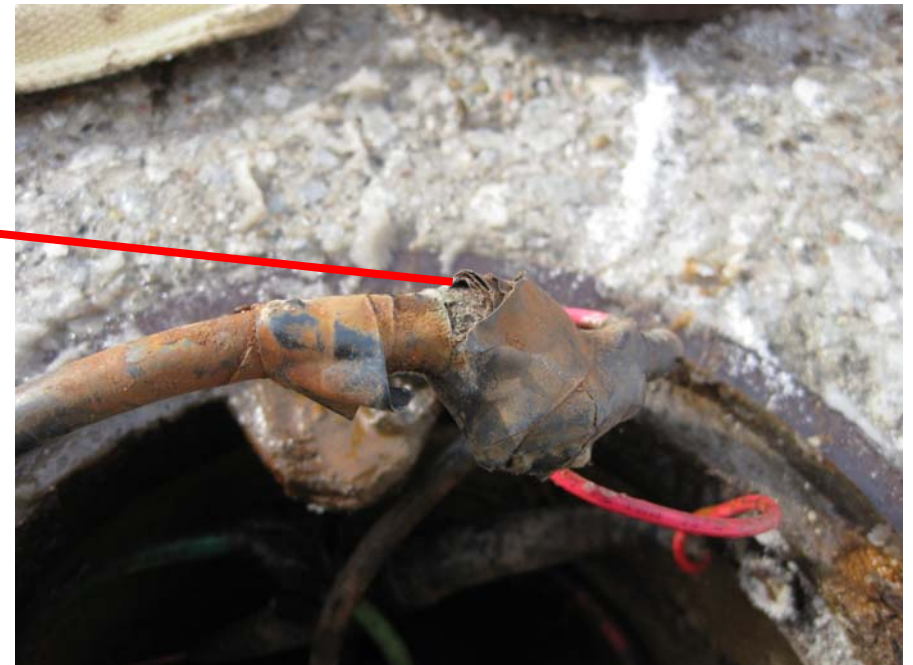
Exposed
conductor

- PVC tape on split-bolt splice improperly applied

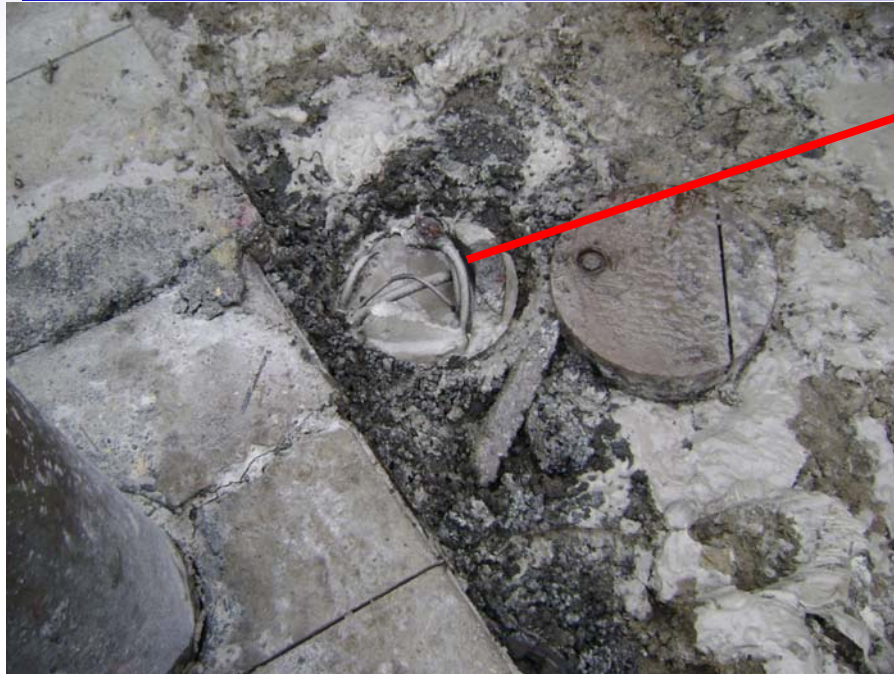
Excavated handwell
with live conductors

Handwell w/ live supply was paved over

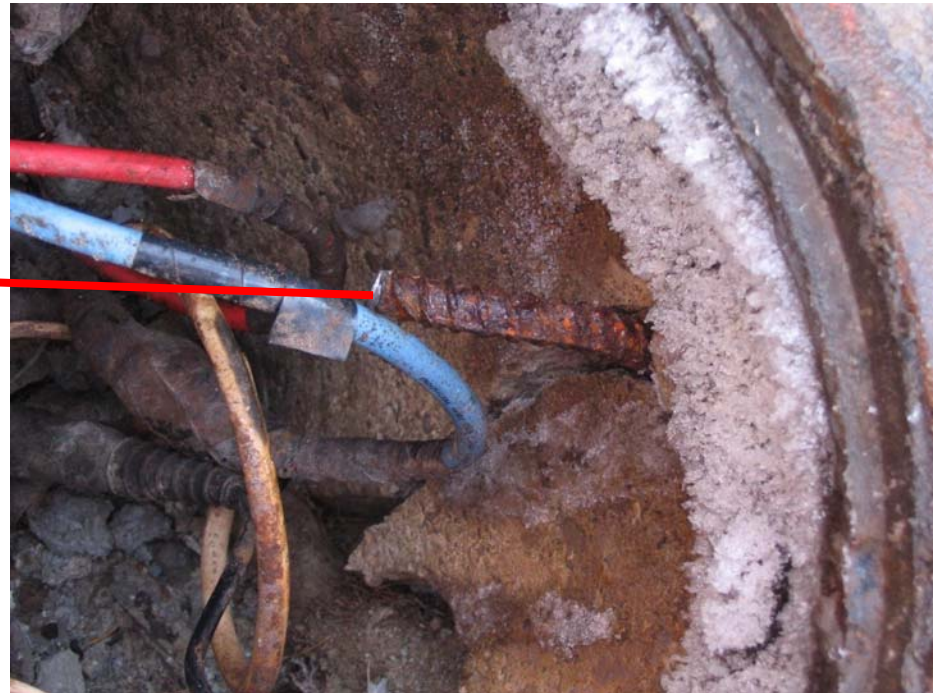
Rebar from sidewalk
has penetrated the
handwell walls

Damage from civil contractor

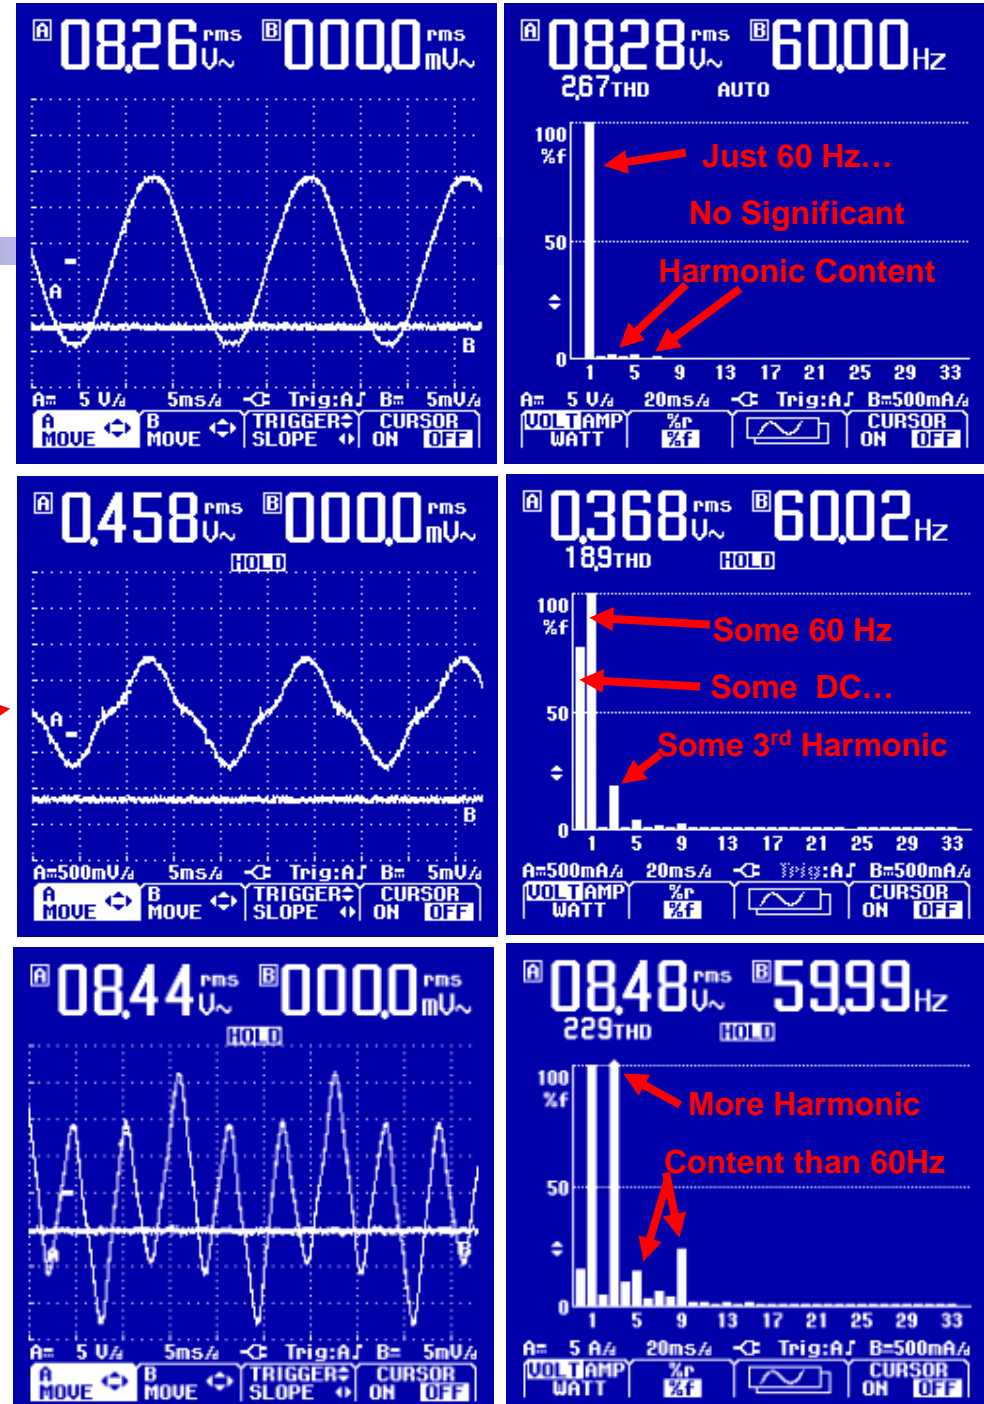
EPRI Finding: Waveform Analysis Allows for ID of Contact Voltage Sources

- 60 Hz Faulted Phase Conductor
- Higher Harmonic Content Neutral to Earth Voltage
- Voltage Snapshot Gas Pipeline to Remote Earth

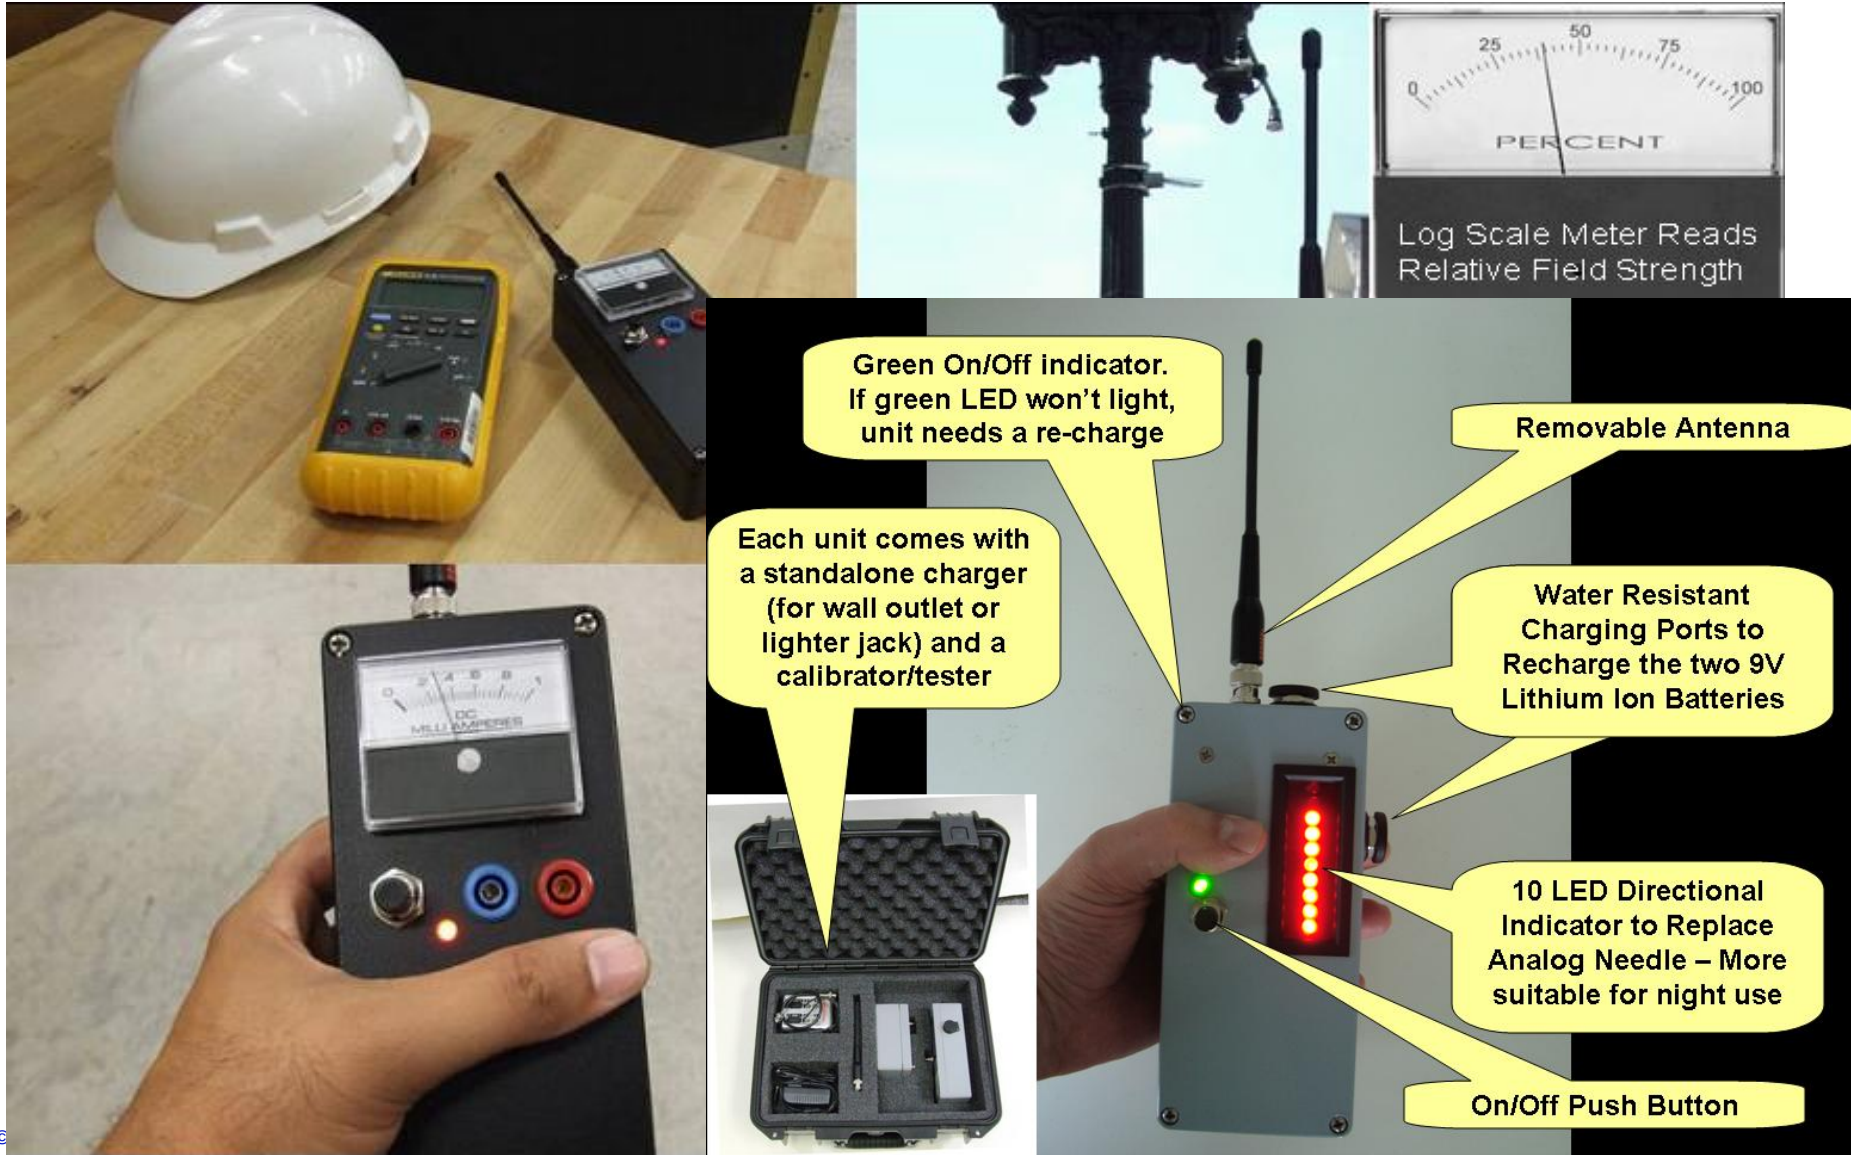
EPRI has Developed an Advanced E-Field Meter for Directional Location of Energized Objects

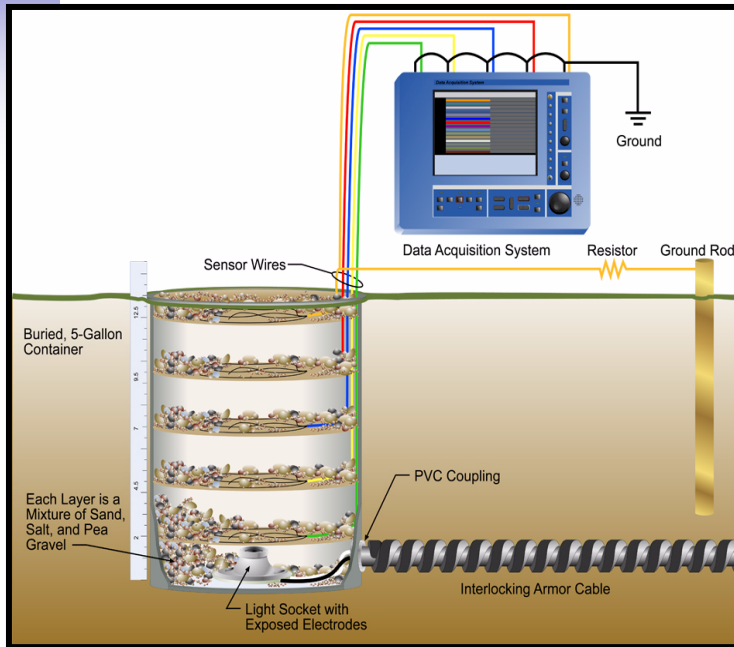
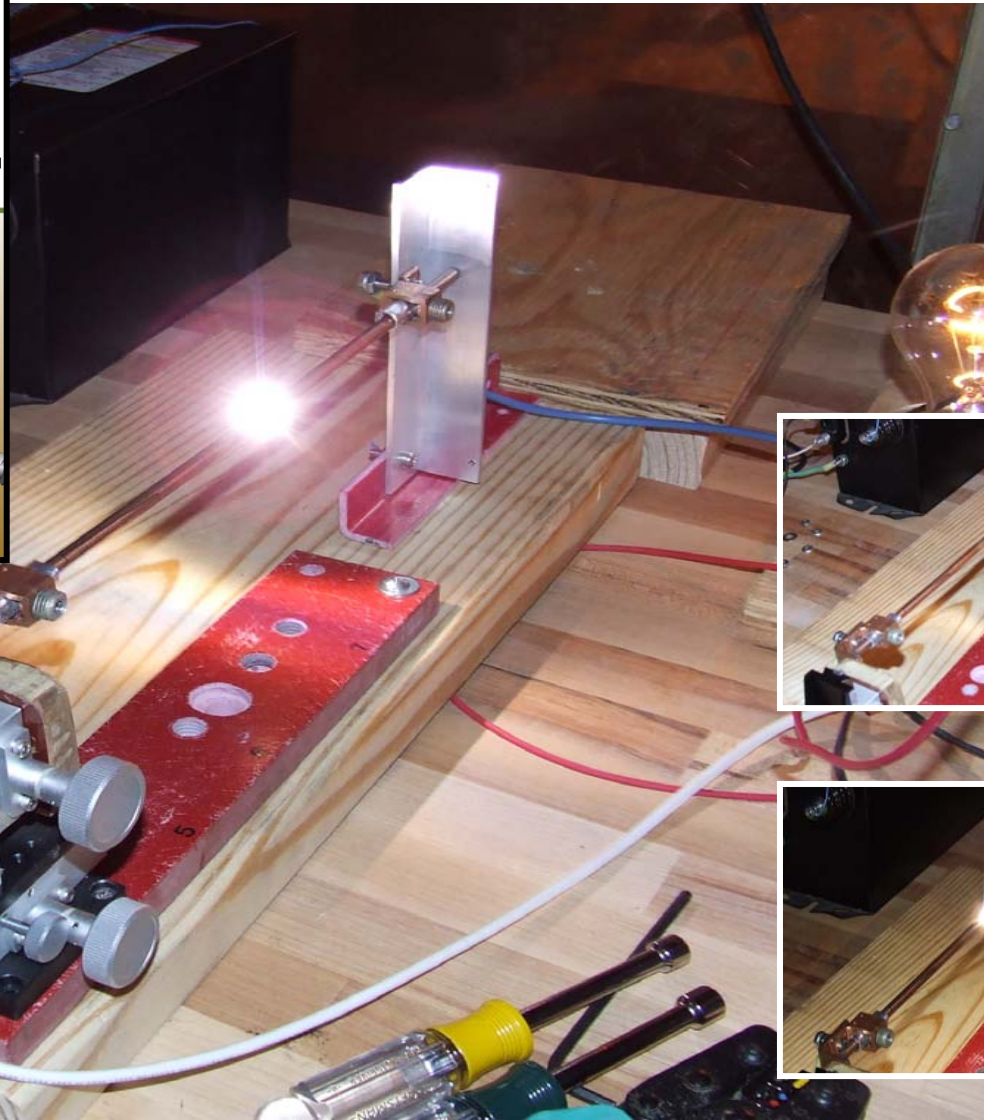
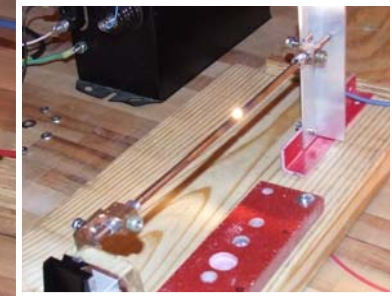
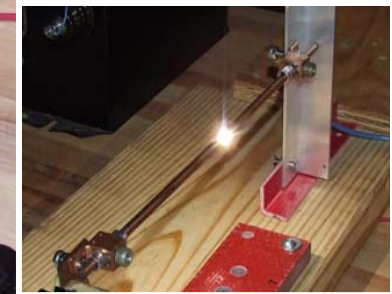
Algorithms to Detect Arcing before it Reaches the Surface of a Sidewalk

- Based on UL Arc Fault Breaker Test
- Stabilized Arc which allows for simplified measurements
- Waveform analysis provides clues for detection
